CERTIFIED BUILDING INSPECTORS

Report#: 2857

HOME INSPECTION REPORT FOR:

SUBJECT PROPERTY:
2271 Lafayette Ave.
Winter Park, FL 32789

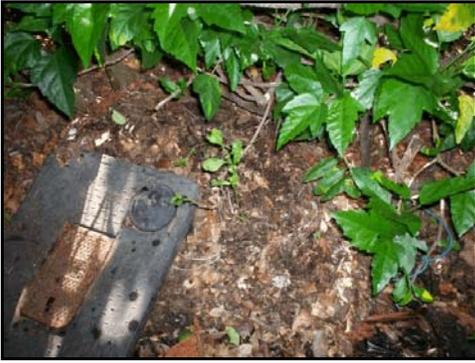
(2) We did not have access to the buried water meter.

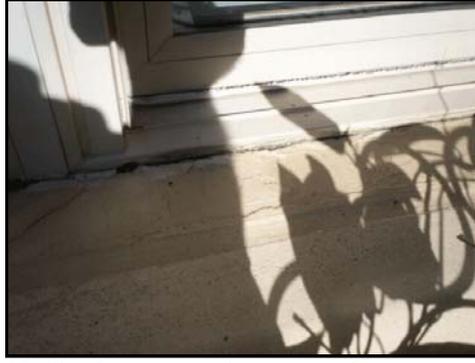
(3) Sealant used at the seams between the window sills and windows.

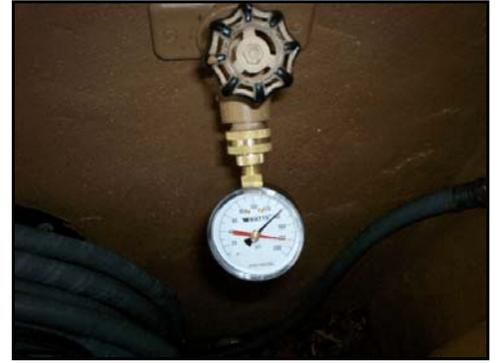
Footnote: there was pressure pump added to the water supply where it enters the house on the right side. The water pressure detected at the hose bib was 140 psi, at least twice the normal water pressure. In addition, there did not appear to be a main water shut off valve t this location.

The water pressure at (140 psi) is excessive, but flow and drainage were adequate. Over the years, a certain amount of debris and sediment does begin to build up in the waste lines, and/or the plumbing fixtures. This condition could cause some restrictions and slower drainage and water pressure. Recommend having a plumbing evaluate the pressure system and/or abandon the system

(4) Water pressure was 140 psi at the hose bib, higher than normal.

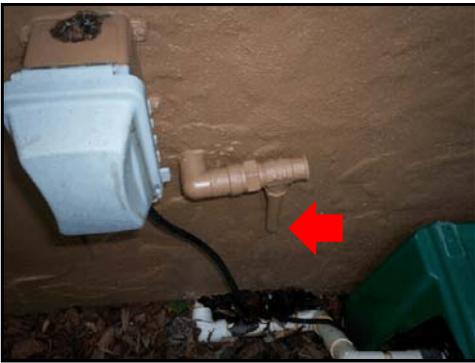
(5) Water leaking from the pressure relief possibly due to the elevated water pressure

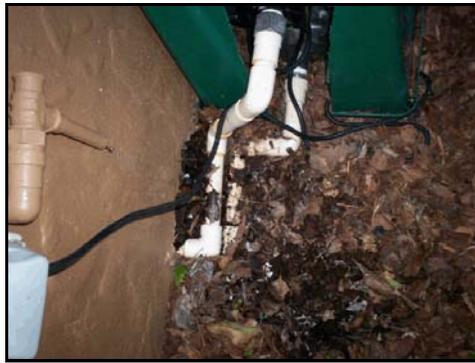
Most of the fixtures have shut off valves below. We do not test shut off valves. The main shut off for the water supply was likely located at the right side of the house, however, it appears to have been removed when the pressure pump system was installed. The fixtures appear to be vented to the exterior based on the adequacy of the drainage. The fixtures and faucets appeared to be the age of the home. They are in working order and condition, with the exception of the conditions noted in the summary or in the pictures at the end of the report.

(6) No main water shut off observed.

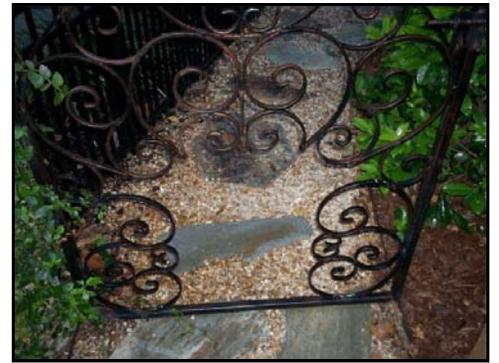
(7) Right rear gate was altered.

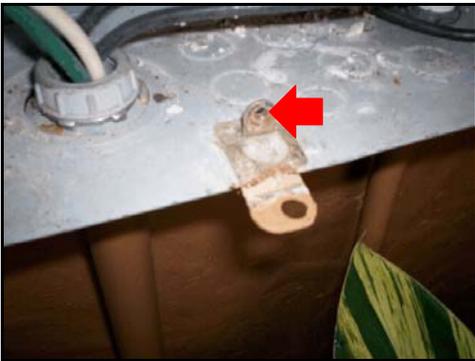
(8) Right electrical cover panel screw "stripped"

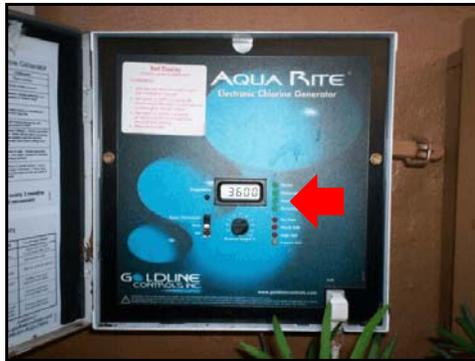
(9) Green indicator lights not illuminated at pool chlorinator.

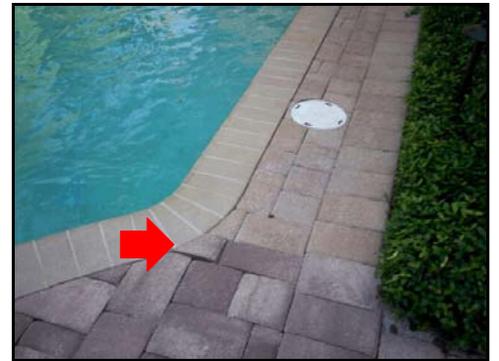
(10) Raise paver at the left front corner of the pool deck

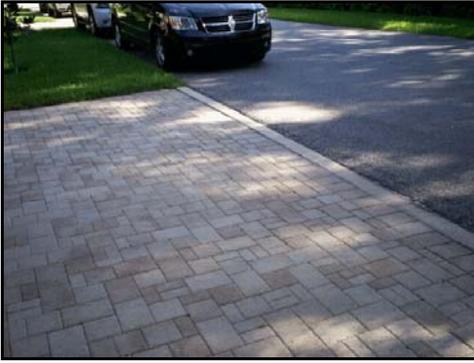
(11) Water from street may slope to the driveway.

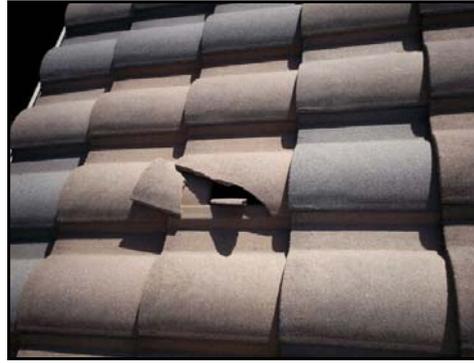
(12) Broken roof tile over the garage.

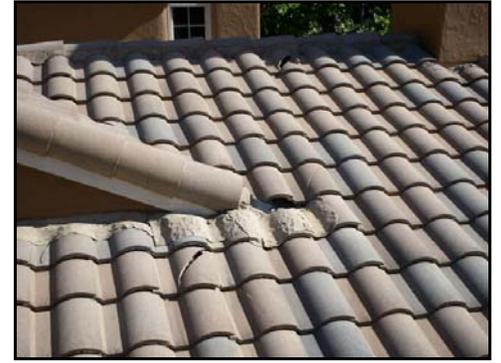
(13) Several broken roof tiles over the family room.

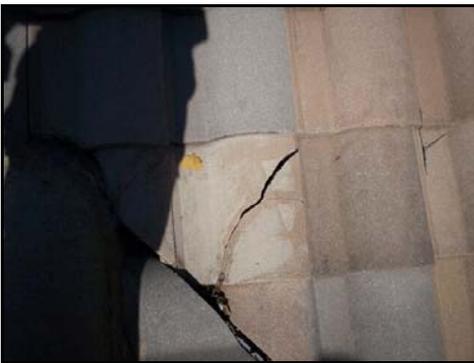
(14) Broken tile in the valley over the family room.

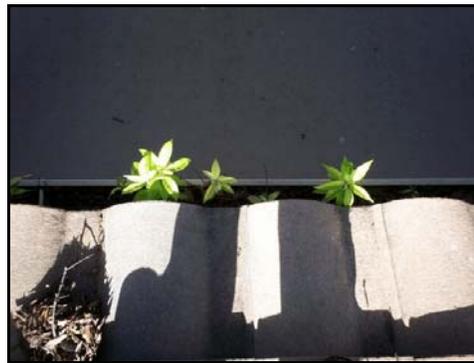
retain water in any low spot, after a period of rain. It is not an issue that the gutters hold some water, other than it provides a breeding area for mosquitos. The gutters did have some debris that should be removed to allow for proper draining, especially at the rear lanai. You may want to consider a screening method to prevent the debris from collecting in the gutters. In addition, the gutter may leak at the seams. These can be sealed to prevent the leaking. We do recommend that the gutter downspouts terminate at least three feet away from the foundation walls. The gutter downspout were served by drain pipes, however, we cannot determine the functionality of the drain pipes.

(15) Debris in the rear gutters

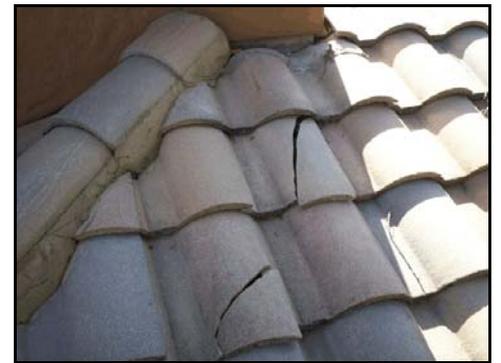
(16) Additional broken tiles.

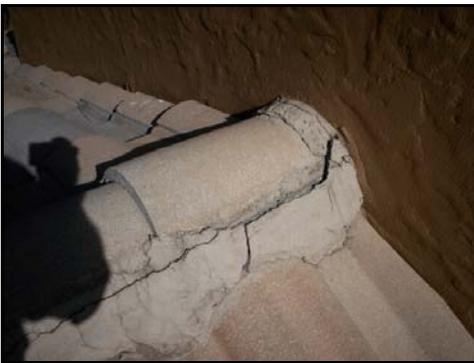
(17) Movement at the ridge cap over the family room.

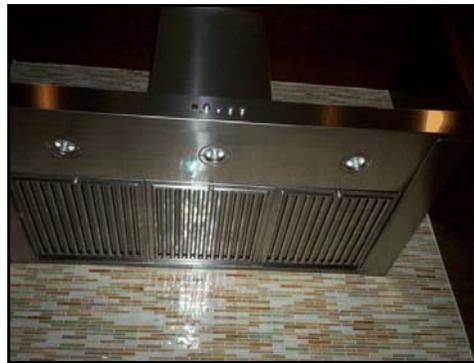
- lights in the kitchen hood,
- one of the laundry room lights

(18) Kitchen exhaust hood lights did not illuminate.

NOTE - This is likely simply due to missing or burned out bulbs. We recommend that the bulbs be replaced and that the light/s checked by you again after this is done.

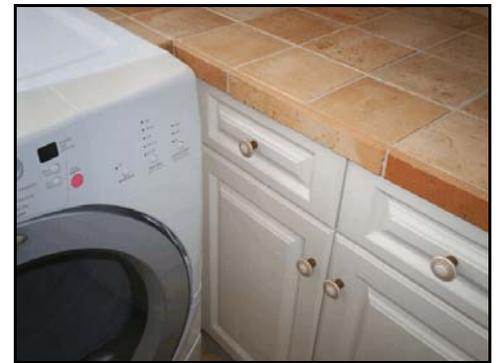
(19) Dryer unit obstructs the door / drawer.

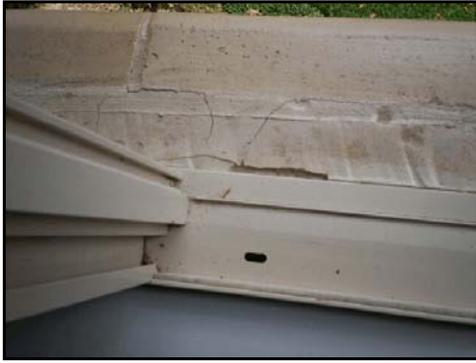
(20) Settlement cracks at the stone window sill outside the front window of the front right guest bedroom

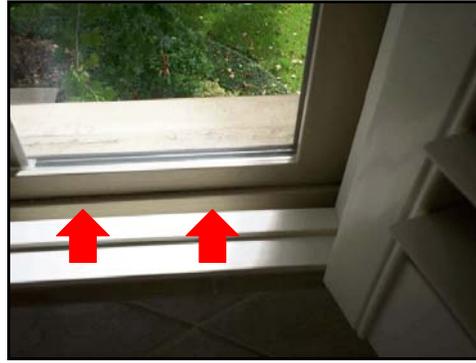
(21) Plantation shutter frame may trap shower water in the right front guest bathroom window area.

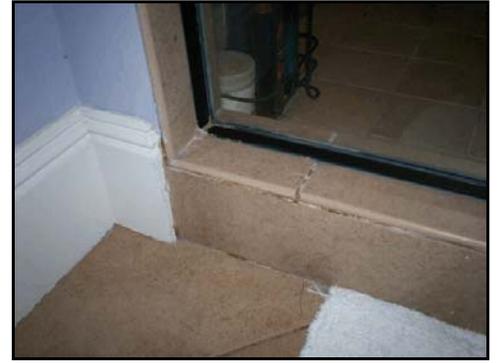
(22) Evidence of water escaping the shower at the right rear guest bathroom.

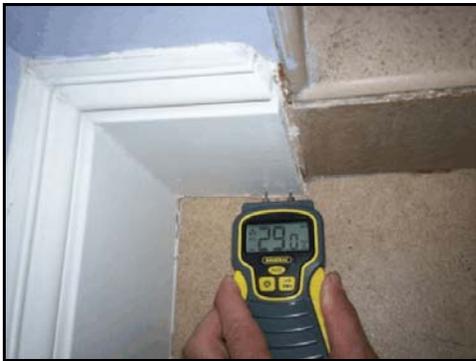
(23) Elevated moisture in the base board outside the guest shower.

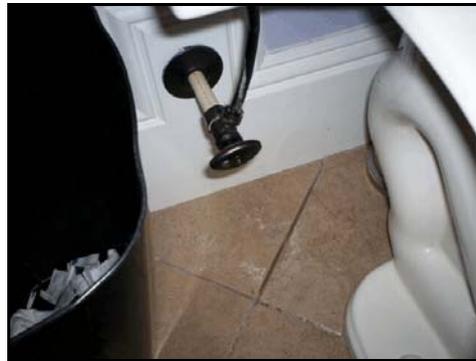
(24) Water leak at eh toilet supply and tank at the left rear guest bathroom.

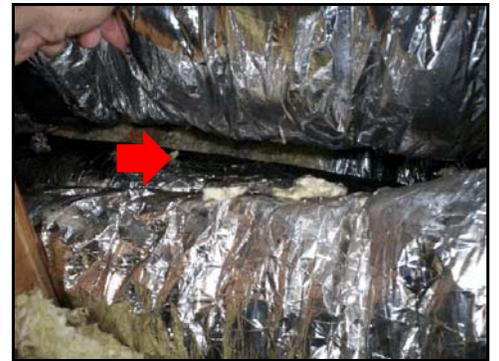
(25) Moisture at the HVAC ducts above the attic access.

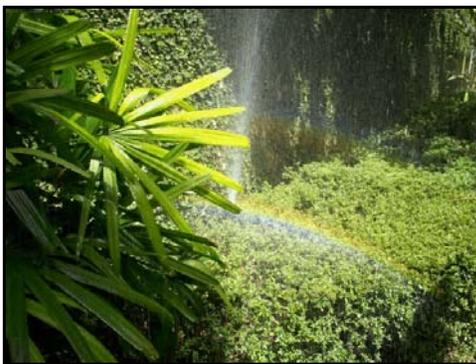
(26) Broken irrigation head zone #3
