CERTIFIED BUILDING INSPECTORS

Report#: 2400-620

NEW HOME-PRE DRYWALL INSPECTION REPORT FOR:

14403 Cedar Hill Dr., Lot 82
Winter Garden, FL 34787

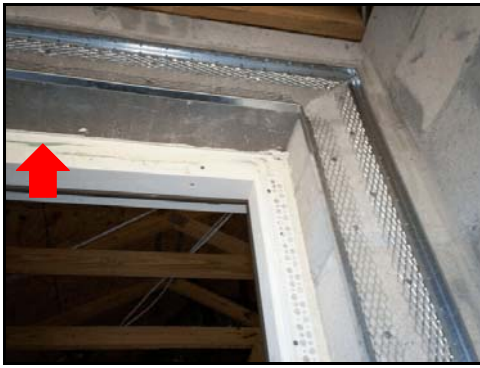
- B. Foam the interior gaps around the exterior door bucks, and water resistant sealant/caulk on the exterior jambs between the doors, jambs and the block. The front door requires additional attention as the sealant has been “broken,” door is not square in jamb, and furring strips on the interior jamb are uneven.

(2) After adjustments are made to the front door, reseal the jamb.

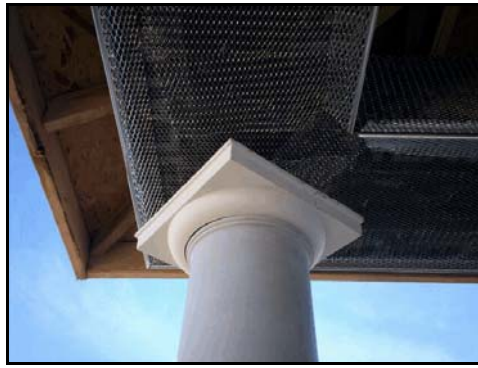
(3) Make sure column caps are square and centered at final install.

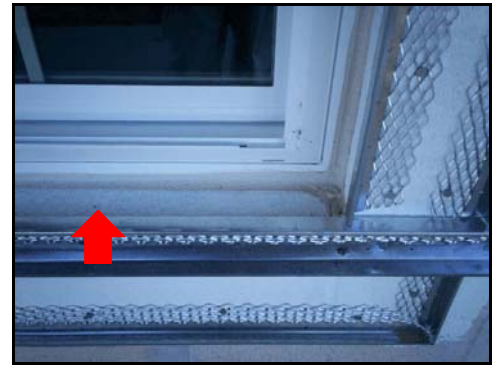
(4) Make sure finished window sills have slope.

- C. Add sealant to the edge of the aluminum thresholds to prevent potential moisture intrusion.
 - D. Make sure stucco at window sills are sloped for proper drainage,

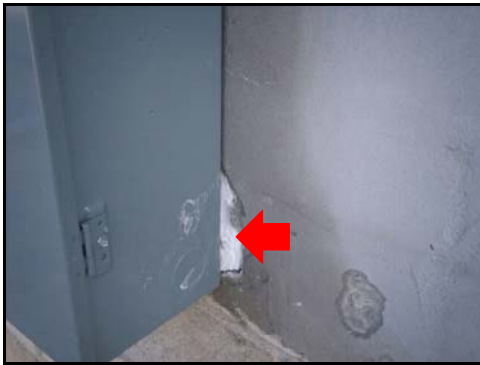
(7) Address gaps in block walls with mortar.

- 1) The following **Exterior** conditions,
 - A. Seal all holes in the block joints, penetrations, electrical outlets, hose bibs, etc. The “stucco coating will not act as a water proof barrier, especially the holes in the block along the right side of the house. Don’t use foam. Current void at eh electrical meter box and the kitchen sidewall exhaust vent.

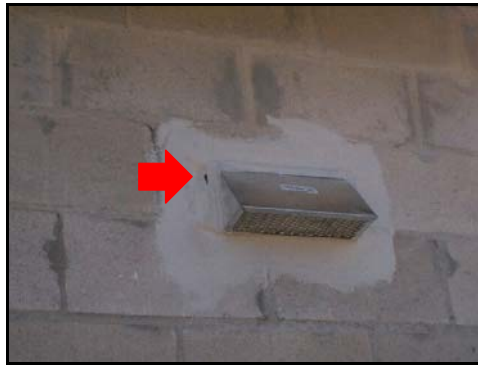
(5) Void in the sealant at the kitchen exhaust hood.

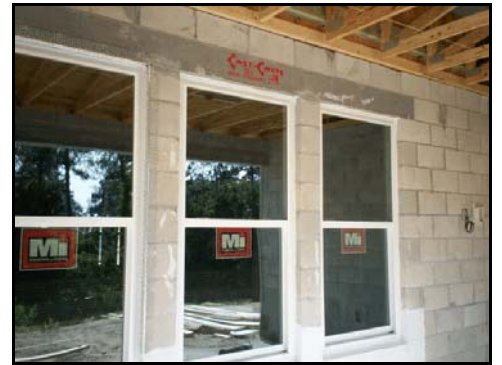
(6) Install stucco corner bead around rear windows.

- G. Finish the stucco lath bead at the rear windows of family room,

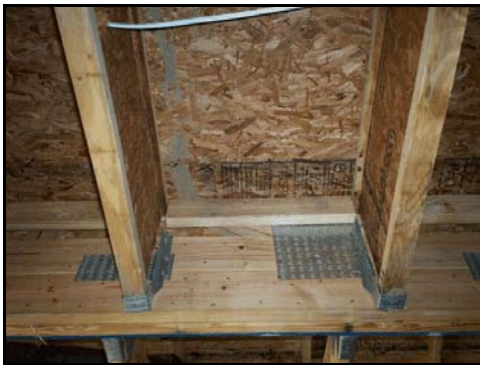
(8) Gaps between floors at the right wall / girder between bedroom #6 and right side of family room.

- A. Make sure any concrete floors that have cracks are properly prepped for tile installation.
- B. Address the draft stops throughout, especially between the right wall of the #6 bedroom and the first floor (along the girder). In addition, where HVAC and wiring runs between floors, and the voids in the wall cavities

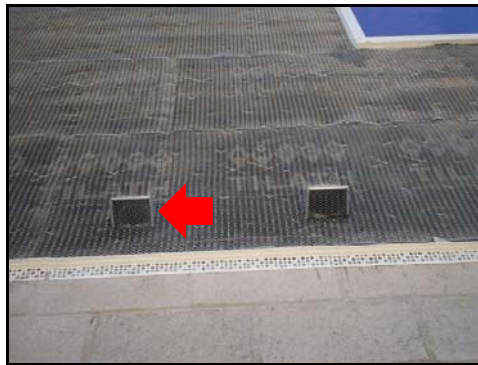
(9) Remove pest screen from dryer vent.

- A. The pest screen should be removed from the dryer vent,
- B. Make sure the vents are square on the ceiling before drywall,

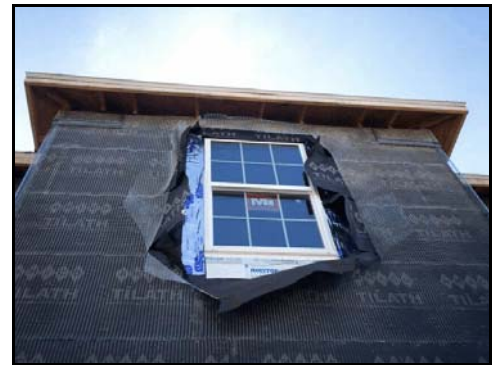
(10) Finish the stucco lath around the front 2nd floor window.

- E. Finish the lath around the front window used to stock the 2nd floor,
 - F. Replace the broken window on the right side of the front right guest bedroom,

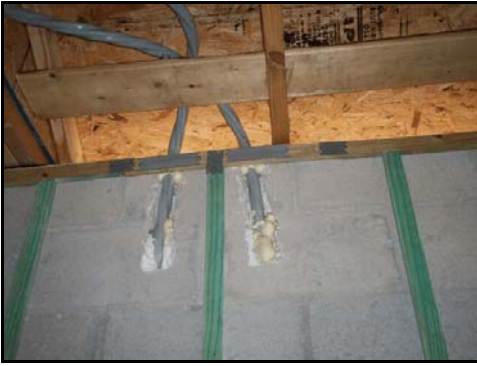
(11) Lintel block “chiseled” to accommodate the main electrical service cables.

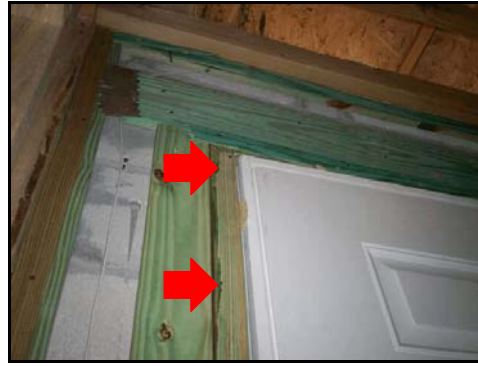
(12) Address the furring strips around the interior of the front door.

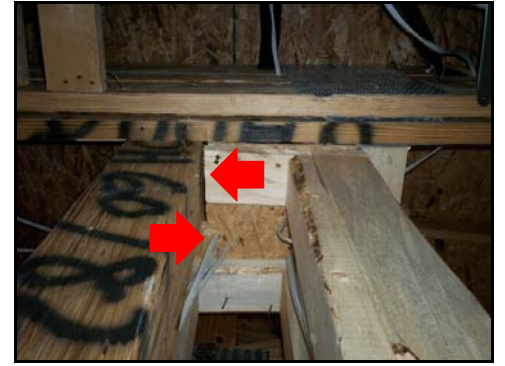
(13) Foam the voids in the wall cavities (draft stops throughout)

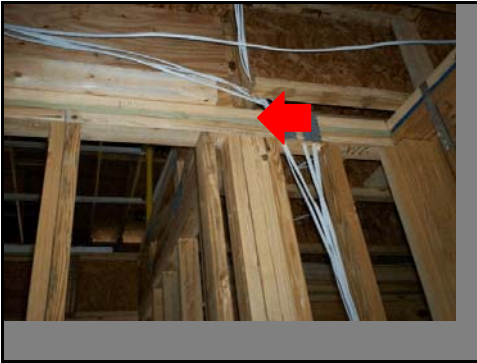
- A. The double LVL beam at the stairs is not required to have anchor / straps to quad 2x4 post to bottom plate?
- B. No bucket for the TJI (J-21) floor joist that runs from left exterior wall of master closet to the right wall of the hall to garage door,
- C. Several TJI’s did not have squash blocking (no plans to review)
- D. The wood studs in the corner of the tub and shower walls should be “nailed” together to prevent the tile grout from cracking in the corners (reduces movement).
- E. Recommend double 2x4 at top of the stairs for handrail nailer (dead wood).

(14) No requirement for anchor straps at double LVL over stairs?

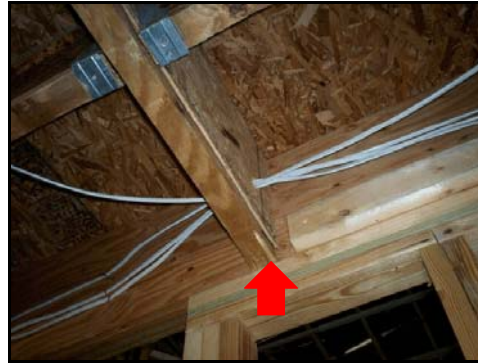
(15) NO bucket for short header beam between TJI's? Toe nailed?

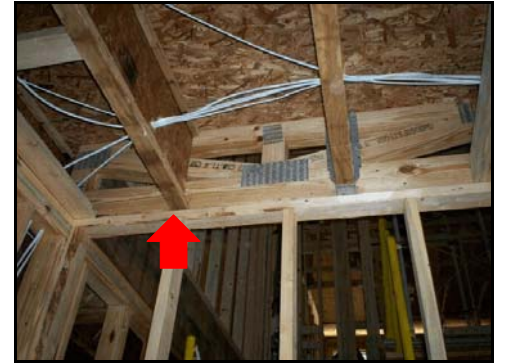
(16) No bucket for J21 TJI at right wall of garage door hall. Right TJI has bucket??

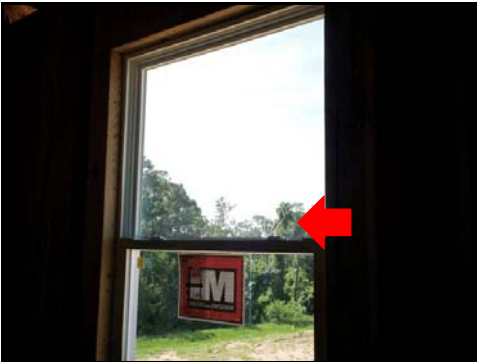
(17) Replace broken on right side of front right guest bedroom.

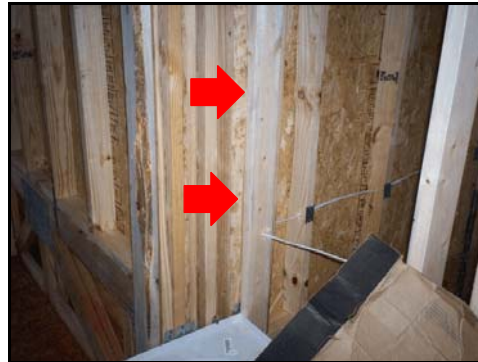
(18) Recommend nailing corner studs at bath / shower locations

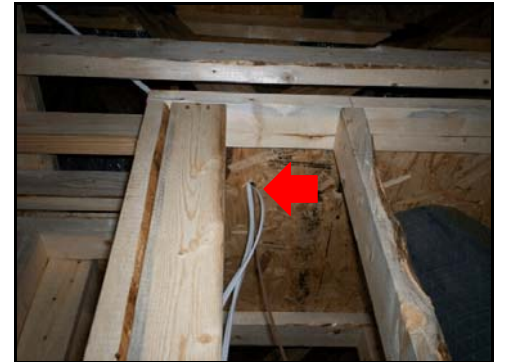
(19) Additional draft foam needed

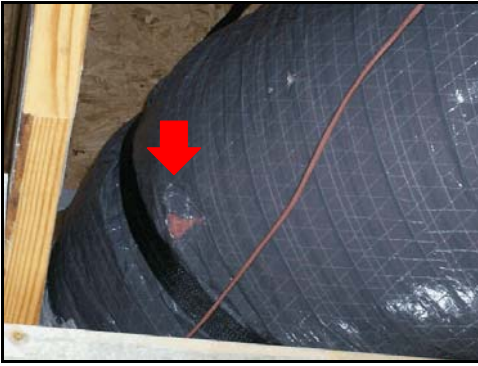
(20) Small tear in the supply duct above the air handler location.

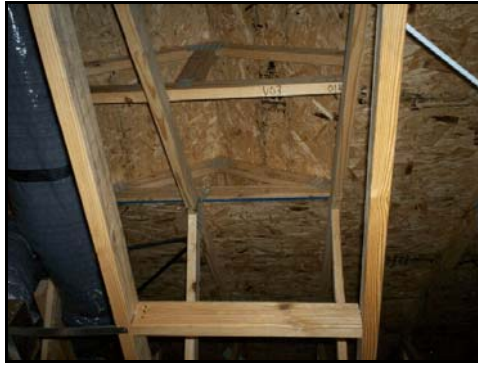
- A. Make sure the ceiling fan rough-ins are centered in the room,
- B. No light fixture in attic access over 2nd floor,

(21) No light at attic access
